Manhole Inspection Summary

Manhole # S39C__024MH

Insp Date: **11/6/08 11:40 AM**

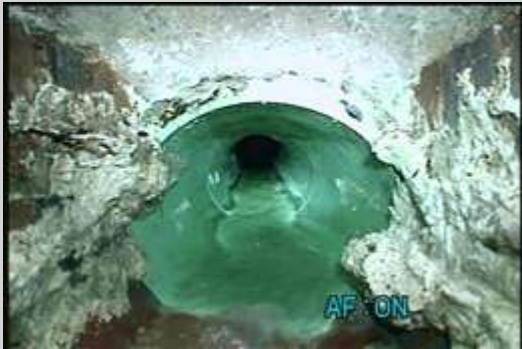
12 O'Clock Outflow

10 in. Circular Gravity Sewer
Pipe Out @ 12 O'Clock

Invert Depth: 11.75 (ft.) Flow Characteristics: Fast

Infiltration: None Pipe Seal Cond: Unknown

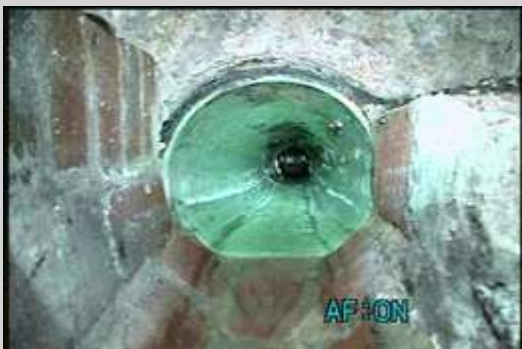
6 O'Clock Inflow

10 in. Circular Gravity Sewer
Pipe In @ 6 O'Clock

Invert Depth: 11.45 (ft.) Flow Characteristics: Fast

Infiltration: None Pipe Seal Cond: Unknown
